Inspection Report

Property Address:
1710 Malcolm Ave #102
Los Angeles CA 90024

Property Address 1710 Malcolm Ave #102 Los Angeles CA 90024	Date of Inspection 12/14/2022	Report ID 20221214-1710-Malcolm-Ave-102
Customer(s) Paula Berry Carla Doss	Time of Inspection 12:30 AM	Real Estate Agent Amanda Robertson

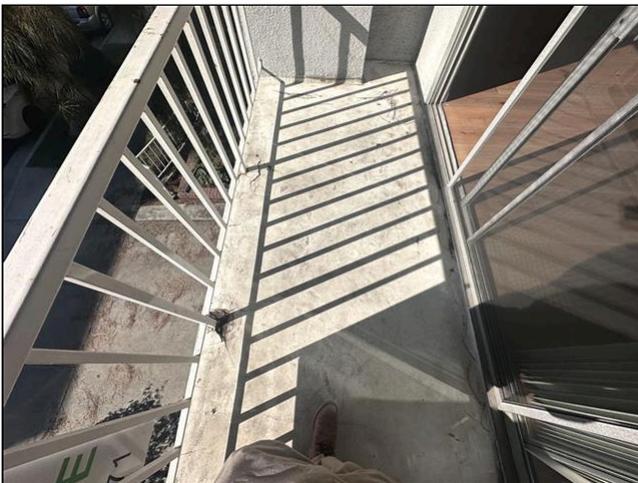
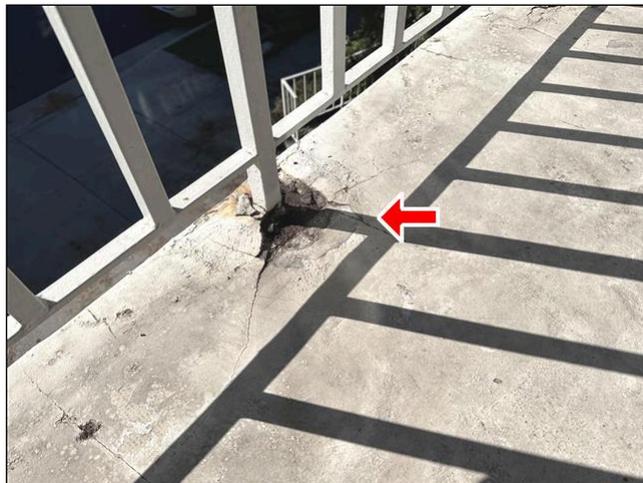
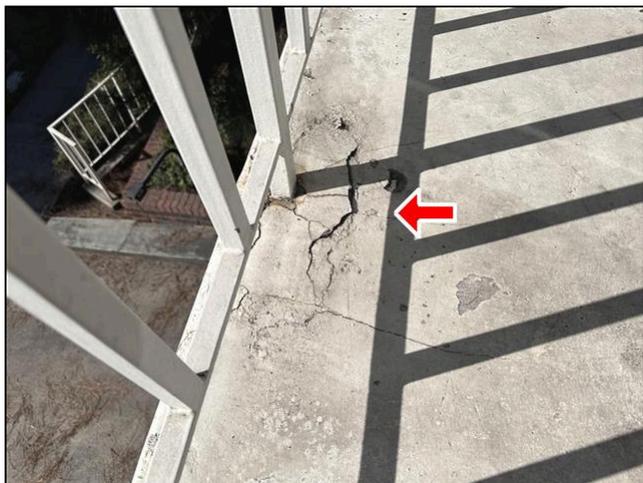
Item 1 - Item 1(Picture) Exterior

- 1. Repair or Replace:** The exterior balcony deck surface is damaged. Also, the railing attachment posts are rusted. The balcony deck is in need of replacement. Suggest further review by a qualified contractor to provide replacement options and costs.

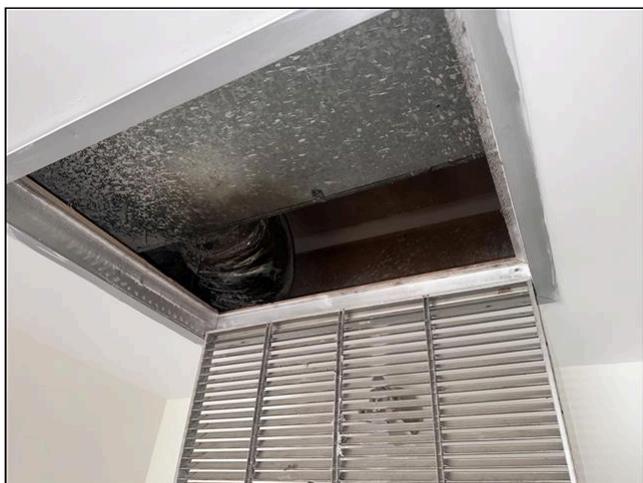
Item 2 - Item 1(Picture) Heating/Central Air

2. **Repair or Replace:** The air filter for the HVAC system is in need of replacement.

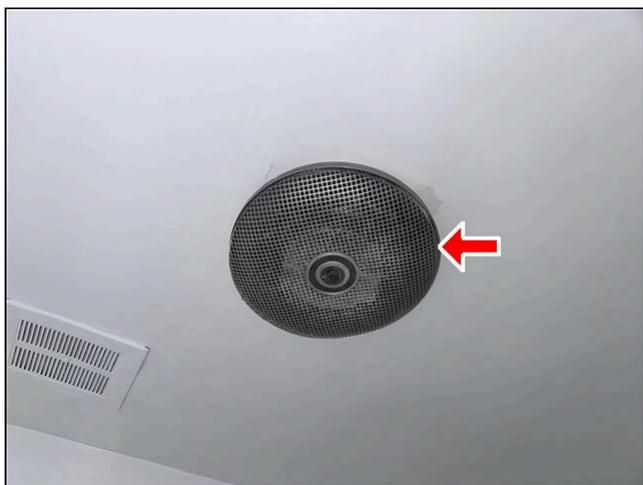
Item 3 - Item 1(Picture) Heating/Central Air

3. **Repair or Replace:** The hallway bathroom ceiling heating element is inoperative. Suggest removal/replacement by a qualified professional.

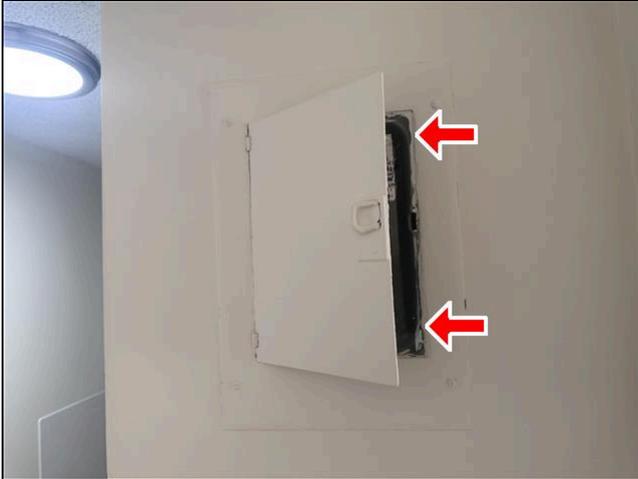
Item 4 - Item 1(Picture) Electrical System

4. **Repair or Replace:** The electrical panel cover does not stay closed. Suggest repair.

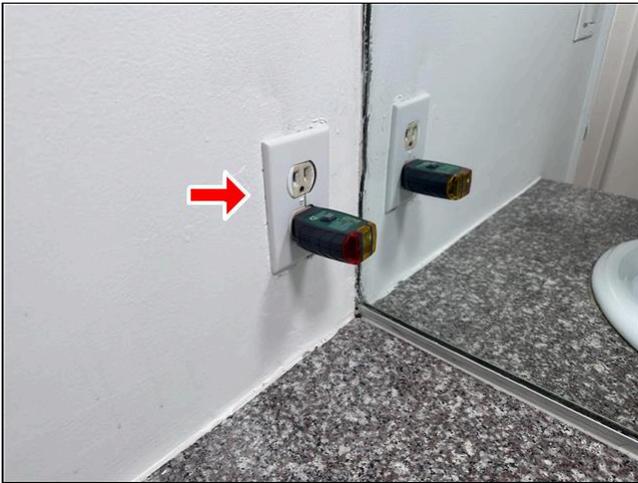
Item 5 - Item 1(Picture) Electrical System

5. (1) **Safety Issue:** The installation of ground fault circuit interrupter (GFCI) devices is advisable at all bathroom outlets within 3 to 6- feet of the sink. GFCI's are strongly recommended. A ground fault circuit interrupter (GFCI) offers protection from shock or electrocution; suggest repairs by a licensed electrical contractor.

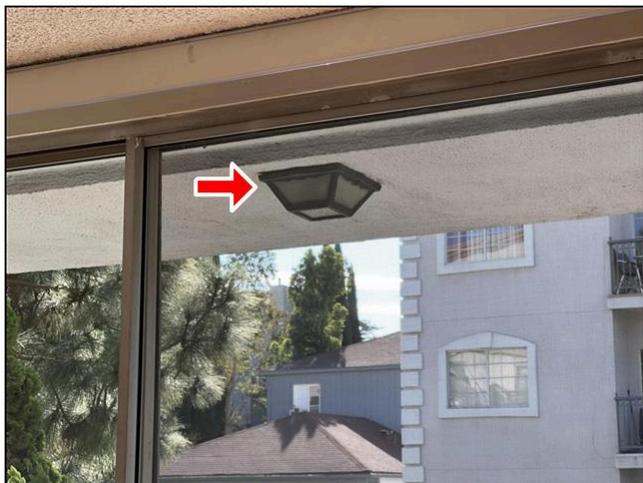
Item 6 - Item 1(Picture) Electrical System

6. (2) **Repair or Replace:** The exterior balcony light bulbs is blown. Suggest replacement of the light bulb.

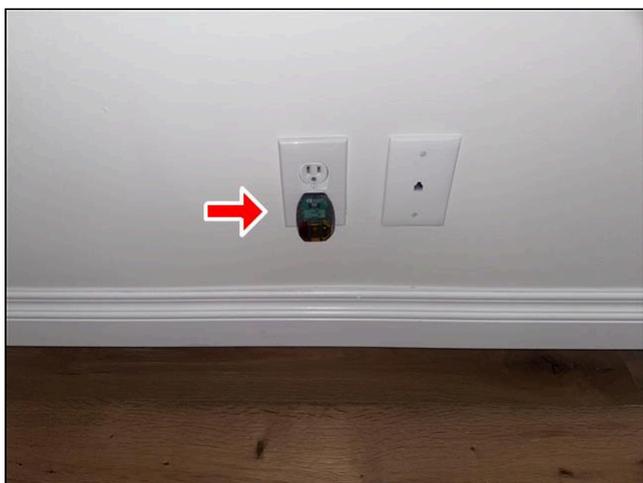
Item 7 - Item 1(Picture)

7. (3) **Repair or Replace:** The electrical outlet at the primary bedroom South interior wall is inoperative. Suggest further investigations and repair by a qualified professional.

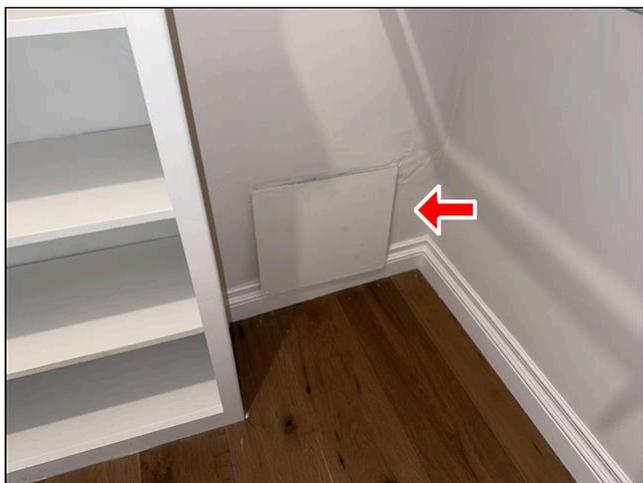
Item 8 - Item 1(Picture) Interiors

8. The primary bathroom tub/shower access panel at the bedroom closet is loose. Suggest repair.

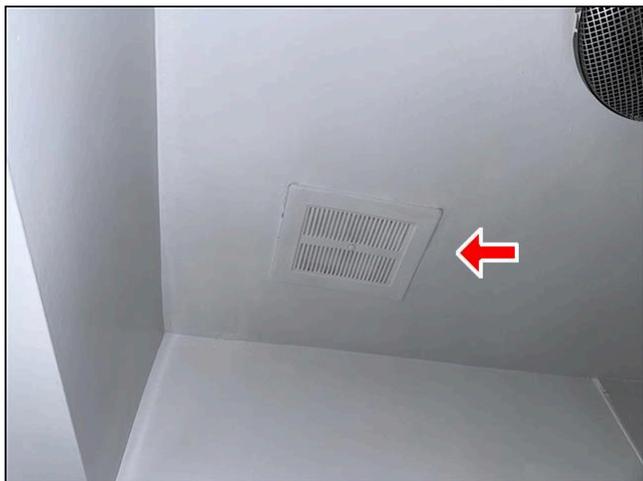
Item 9 - Item 1(Picture) Insulation & Ventilation

9. **Repair or Replace:** The hallway bathroom ceiling fan is noisy when operated. Suggest replacement of the fan by a qualified professional.

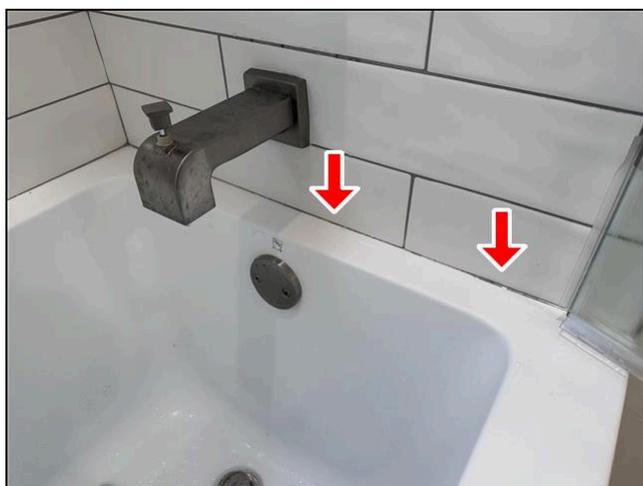
Item 10 - Item 1(Picture) Interiors

10. **Repair or Replace:** The grout at the primary bathroom tub perimeter loose in various locations. Suggest repair to prevent moisture intrusion.

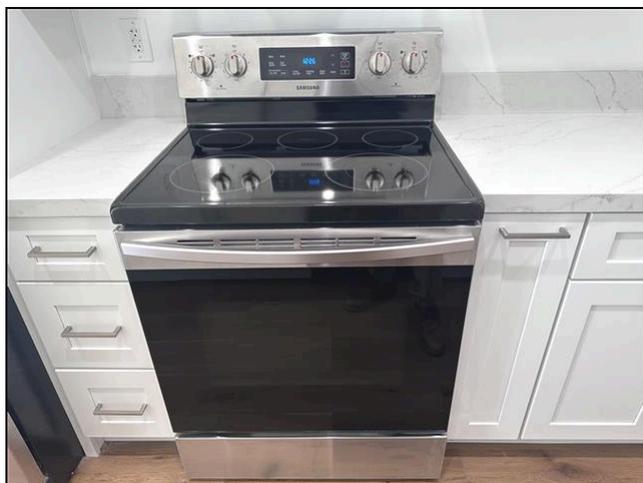
Item 11 - Item 1(Picture) Appliances

11. **Safety Issue:** The anti-tip bracket for the kitchen stove has not been installed. The anti-tip bracket provides extra protection when excess force is applied to an open oven door. Suggest the installation by a qualified professional.

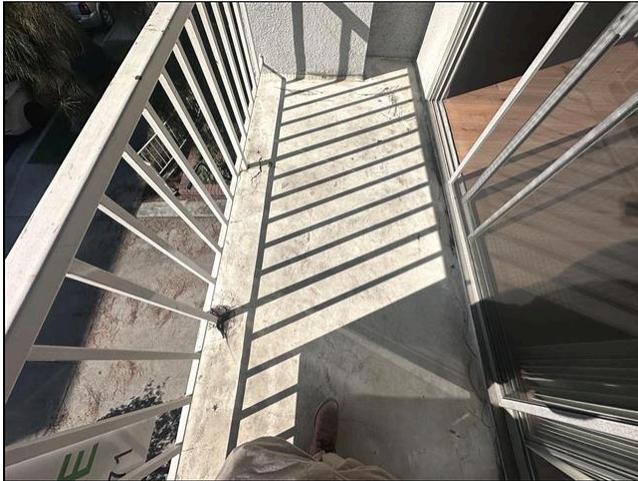
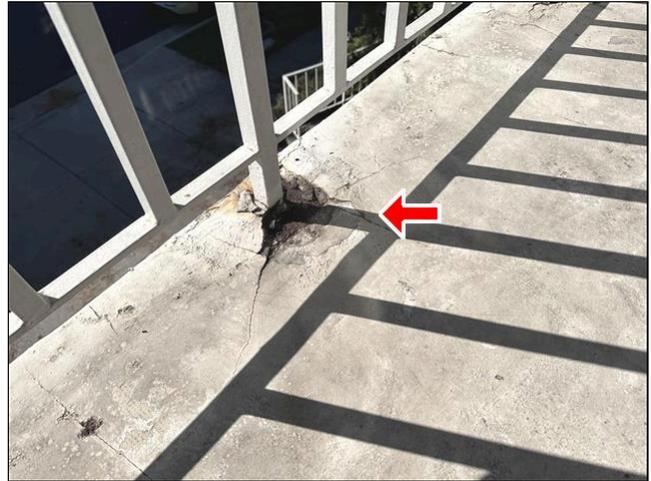
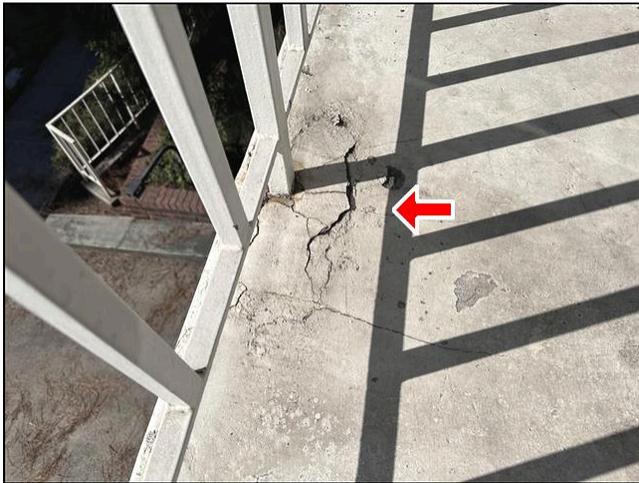
2.0 Item 1(Picture) Exterior

Repair or Replace: The exterior balcony deck surface is damaged. Also, the railing attachment posts are rusted. The balcony deck is in need of replacement. Suggest further review by a qualified contractor to provide replacement options and costs.

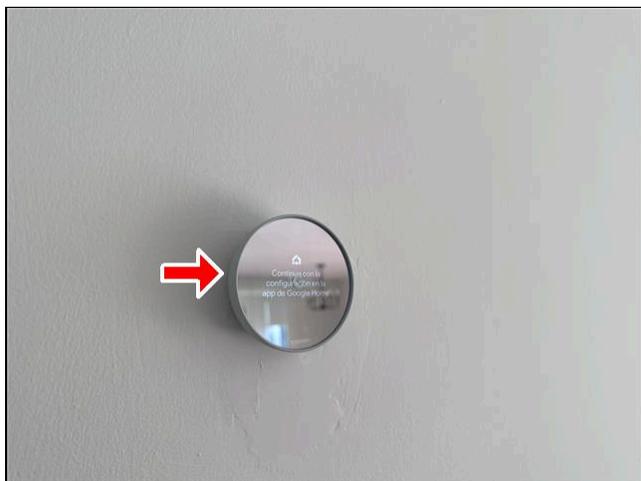
4.2 Item 1(Picture) Heating/Central Air

Monitor: Unable to operate the HVAC thermostat control during the inspection. Unable to test and operate the HVAC system during the inspection.

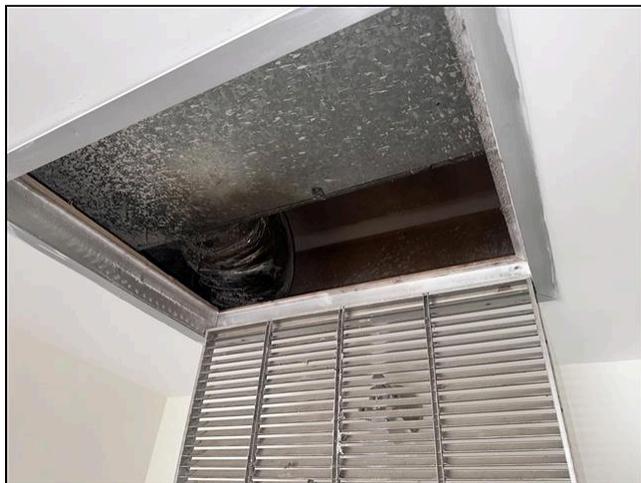
4.5 Item 1(Picture) Heating/Central Air

Repair or Replace: The air filter for the HVAC system is in need of replacement.

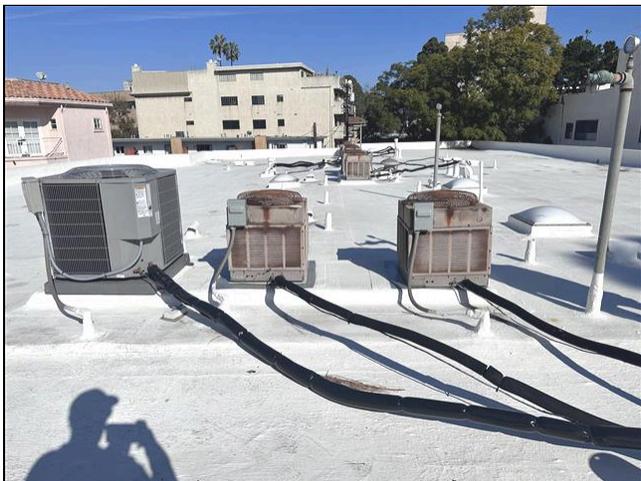
4.7 Item 1(Picture) Heating/Central Air

(1) **Monitor:** The air conditioning condensers at the roof at not labeled. Unable to determine which unit serves the condominium.

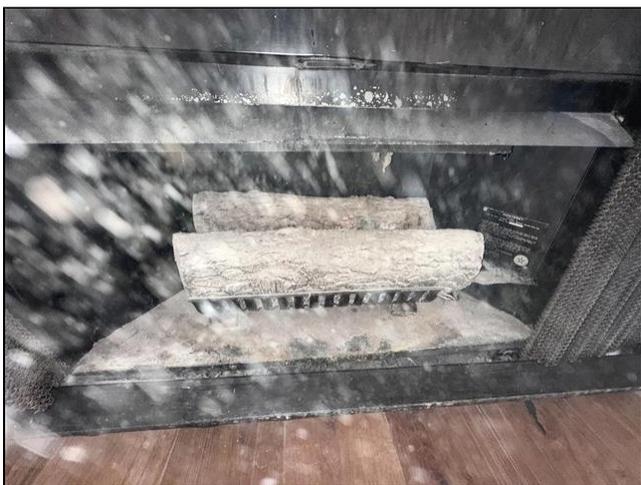
4.11 Item 1(Picture) Fireplace

Monitor: The living room gas pilot was not lit at the time of the inspection. I was unable to test and operate the fireplace. Because of this, we recommend further evaluation/safety check be performed by the local gas company before the end of your contingency period.

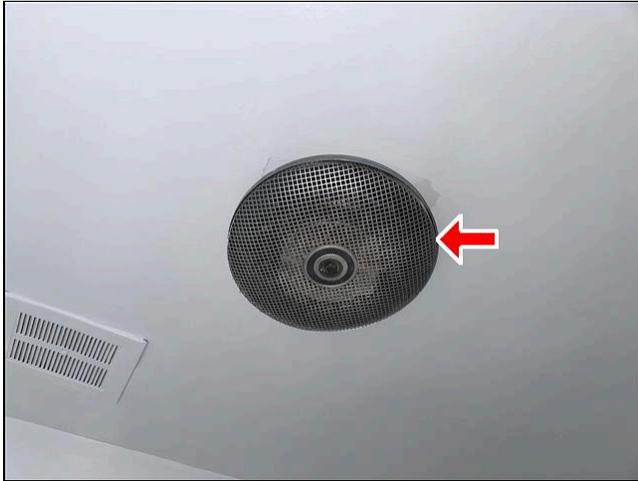
4.14 Item 1(Picture) Heating/Central Air

Repair or Replace: The hallway bathroom ceiling heating element is inoperative Suggest removal/ replacement by a qualified professional.

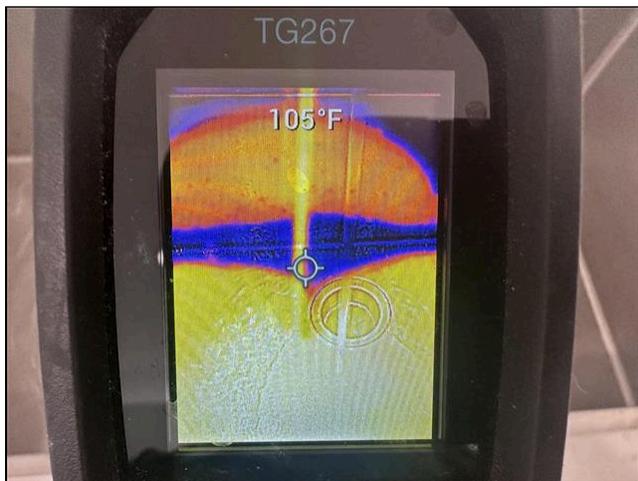
5.2 Item 1(Picture) Plumbing System

Note/Monitor: The water heater was operational and produced hot water at time of inspection.

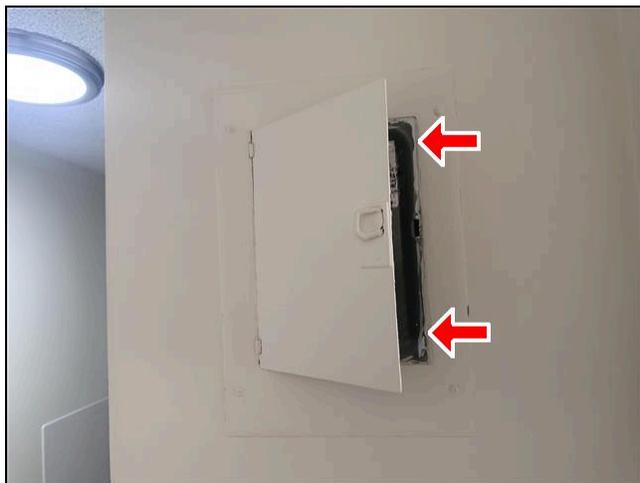
6.0 Item 1(Picture) Electrical System

Repair or Replace: The electrical panel cover does not stay closed. Suggest repair.

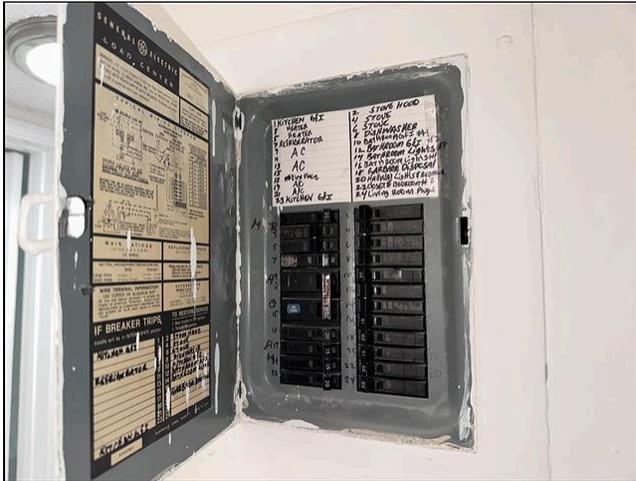
6.1 Item 1(Picture) Electrical System

Monitor: Due to the paint/plaster covering the electrical panel cover, the cover panel was not removed at the time of the inspection. Because of this, we recommend further evaluation/safety check be performed by qualified electrician.

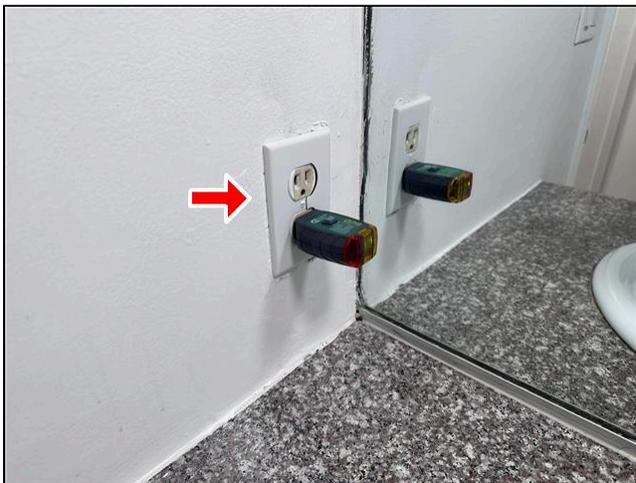
6.2 Item 1(Picture) Electrical System

(1) **Safety Issue:** The installation of ground fault circuit interrupter (GFCI) devices is advisable at all bathroom outlets within 3 to 6- feet of the sink. GFCI's are strongly recommended. A ground fault circuit interrupter (GFCI) offers protection from shock or electrocution; suggest repairs by a licensed electrical contractor.

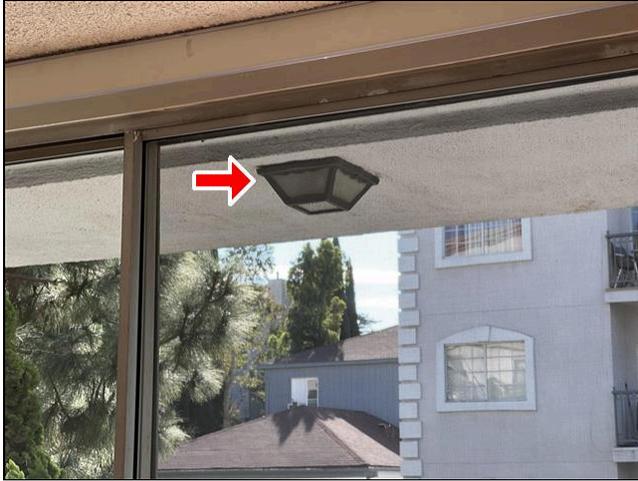
6.2 Item 2(Picture) Electrical System

(2) **Repair or Replace:** The exterior balcony light bulbs is blown. Suggest replacement of the light bulb.

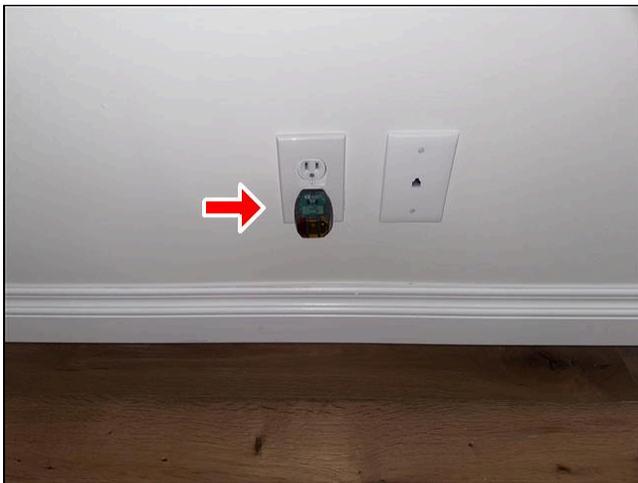
6.2 Item 3(Picture)

(3) **Repair or Replace:** The electrical outlet at the primary bedroom South interior wall is inoperative. Suggest further investigations and repair by a qualified professional.

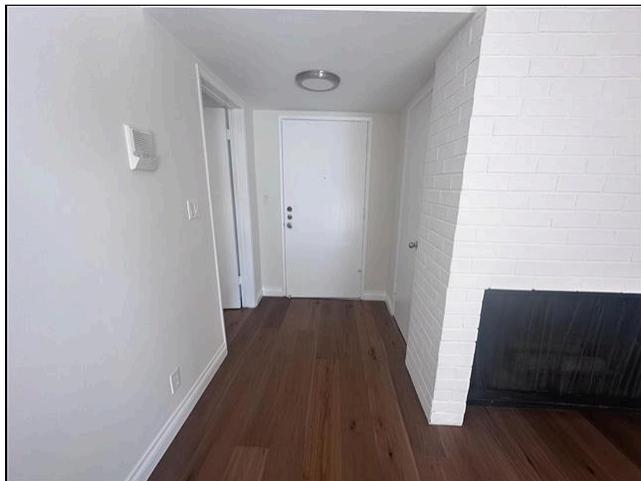
8.0 Item 1(Picture) Interiors

Monitor: Many doors and window openings are out-of-square and the floor exhibits an apparent slope in many locations. Movement of the condominium is apparent. Suggest further evaluation by a qualified trades person and structural engineer for determination, evaluation and/or corrective repairs if required. Since this inspection is visual in nature, it is always recommended that any movement observed be further evaluated to prevent damage and to insure the integrity of the structure is kept in tact.

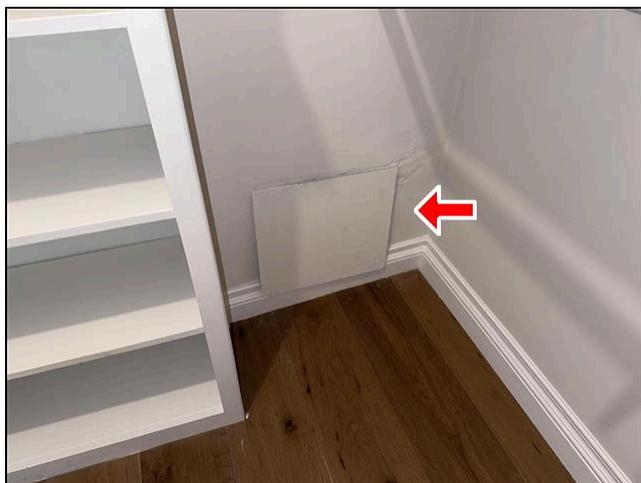
8.1 Item 1(Picture) Interiors

The primary bathroom tub/shower access panel at the bedroom closet is loose. Suggest repair.

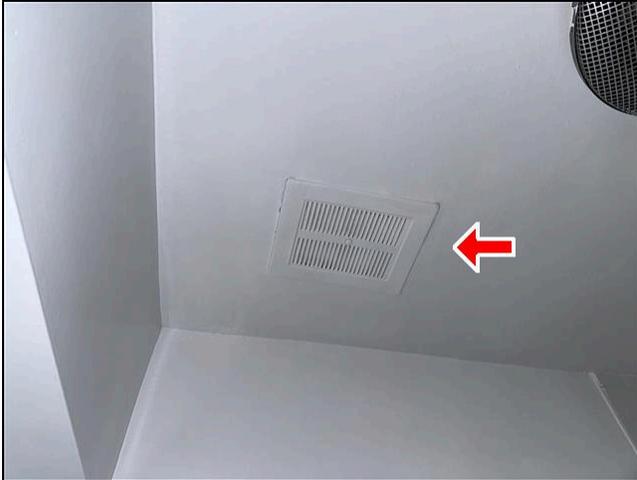
8.8 Item 1(Picture) Insulation & Ventilation

Repair or Replace: The hallway bathroom ceiling fan is noisy when operated. Suggest replacement of the fan by a qualified professional.

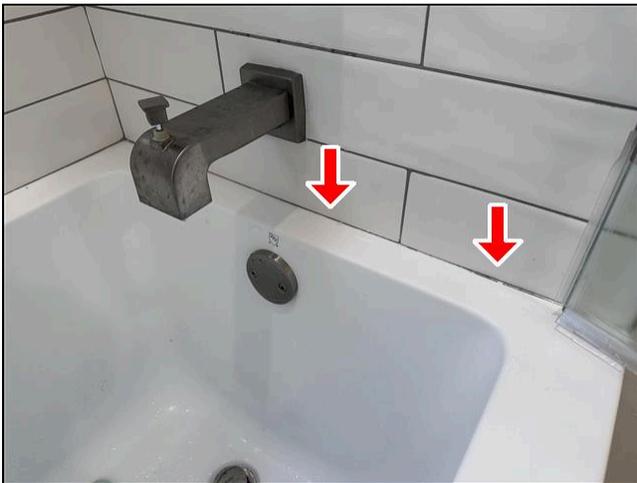
8.9 Item 1(Picture) Interiors

Repair or Replace: The grout at the primary bathroom tub perimeter loose in various locations. Suggest repair to prevent moisture intrusion.

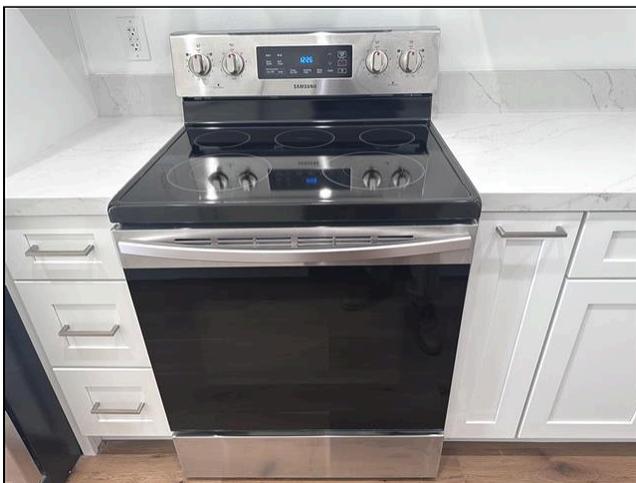
10.1 Item 1(Picture) Appliances

Safety Issue: The anti-tip bracket for the kitchen stove has not been installed. The anti-tip bracket provides extra protection when excess force is applied to an open oven door. Suggest the installation by a qualified professional.

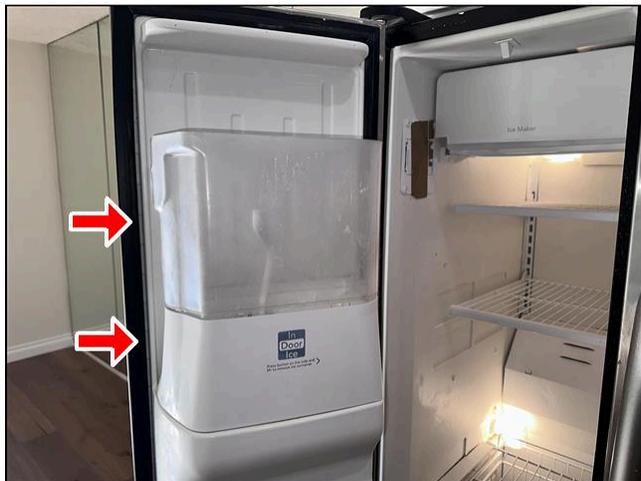
10.10 Item 1(Picture) Appliances

(1) **Repair or Replace:** The kitchen refrigerator in door ice holder is loose/damaged. Suggest repair.

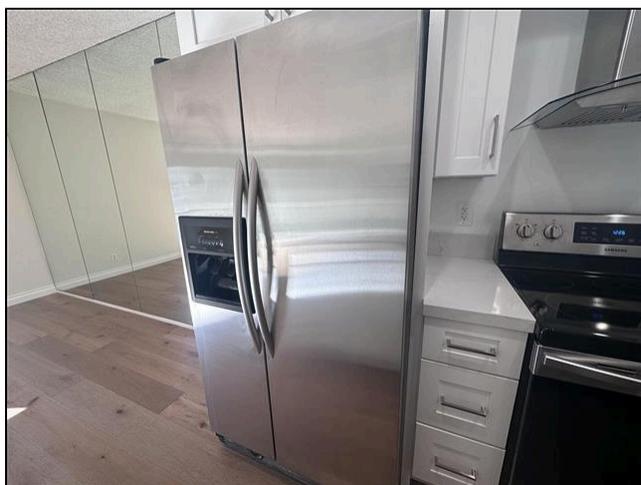
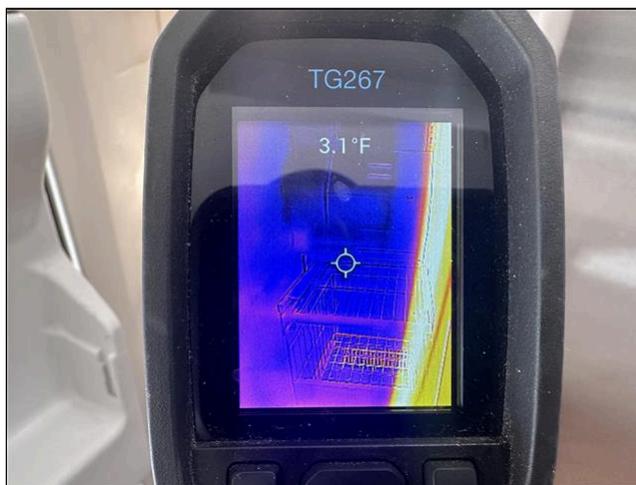
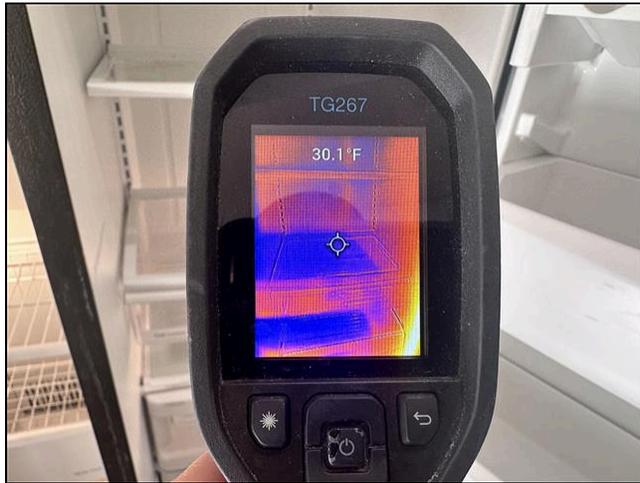
10.10 Item 2(Picture) Appliances

(2) **Inspected:** The kitchen refrigerator was operating during the inspection.
